**TIMBER CREEK
COMMUNITY DEVELOPMENT
DISTRICT**

JANUARY 11, 2024

AGENDA PACKAGE

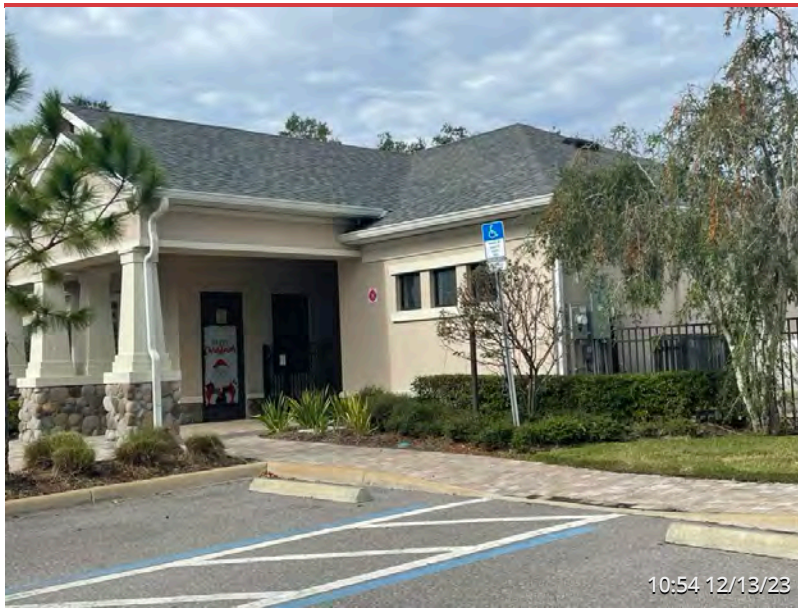
AMENITY CENTER.

Trim the ornamental grass off of the curbing.

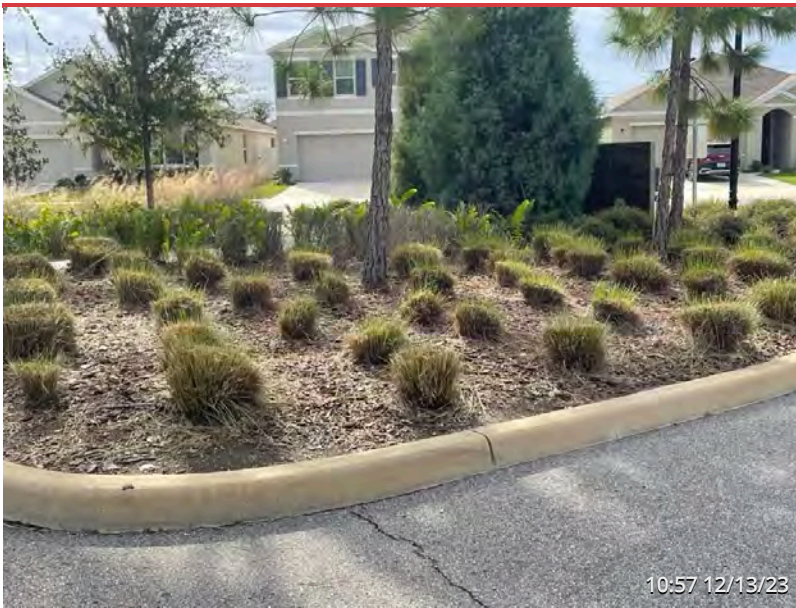
AMENITY CENTER.

The Iris bed needs additional plants. It may be prudent to install a more suitable plant for this area. In the mean-time this area would look better if all of the plants were removed.

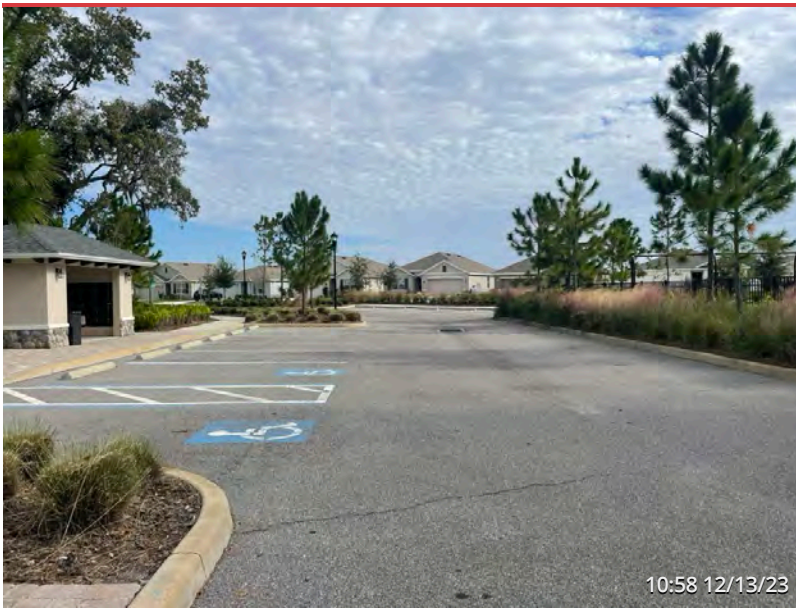
AMENITY CENTER.

Remove the lone Fern plant.

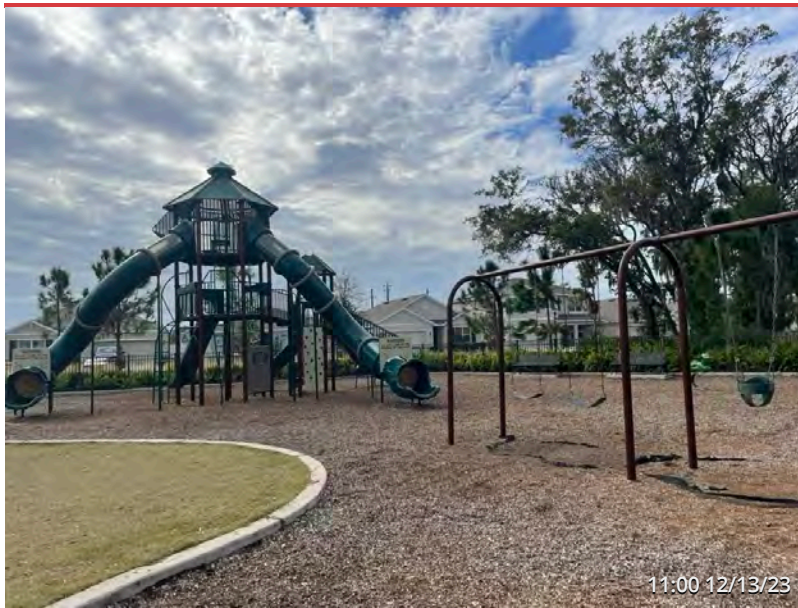
AMENITY CENTER.

The third tier of the playground needs to be repaired. The District Manager is in discussions with various vendors to repair the playground equipment.

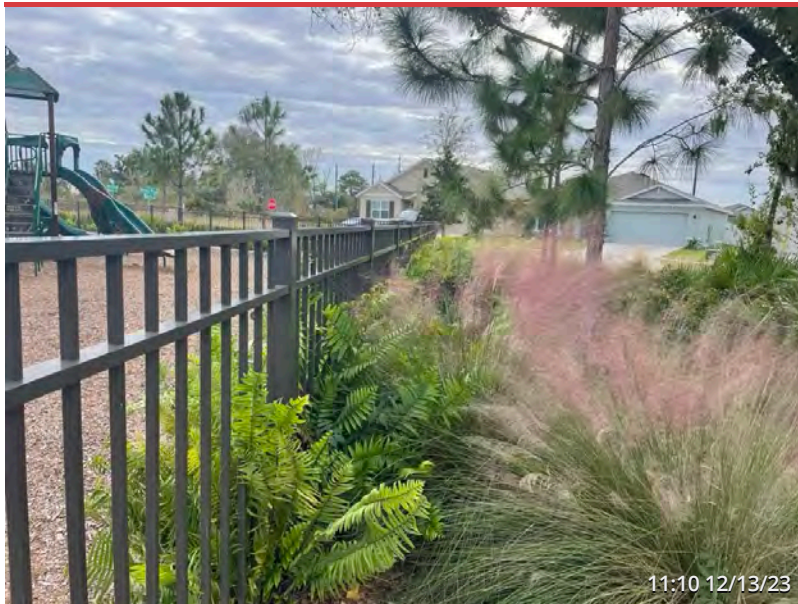
AMENITY CENTER.

Trim the Fern plants growing through the fence.

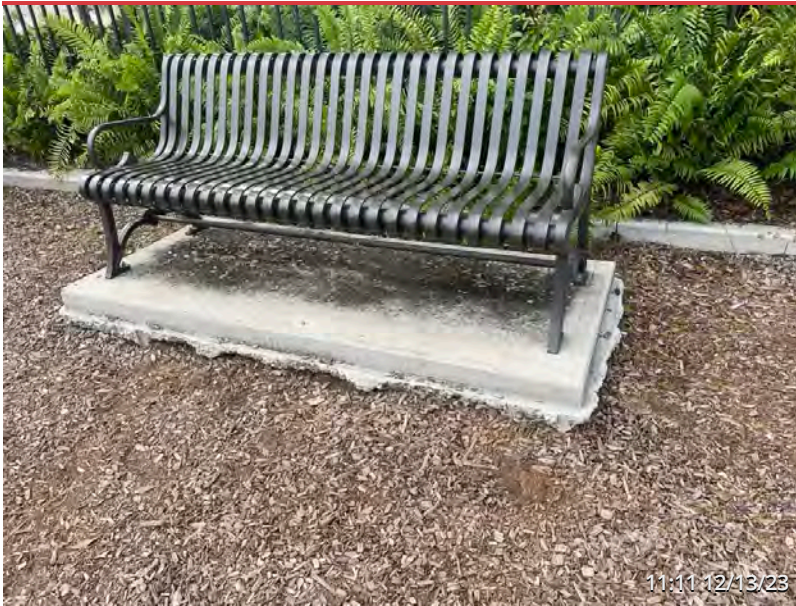
AMENITY CENTER.

Assigned To District Manager.
Jagged concrete base on the bench is a potential hazard.
