**TIMBER CREEK
COMMUNITY DEVELOPMENT
DISTRICT**

JANUARY 11, 2024

AGENDA PACKAGE

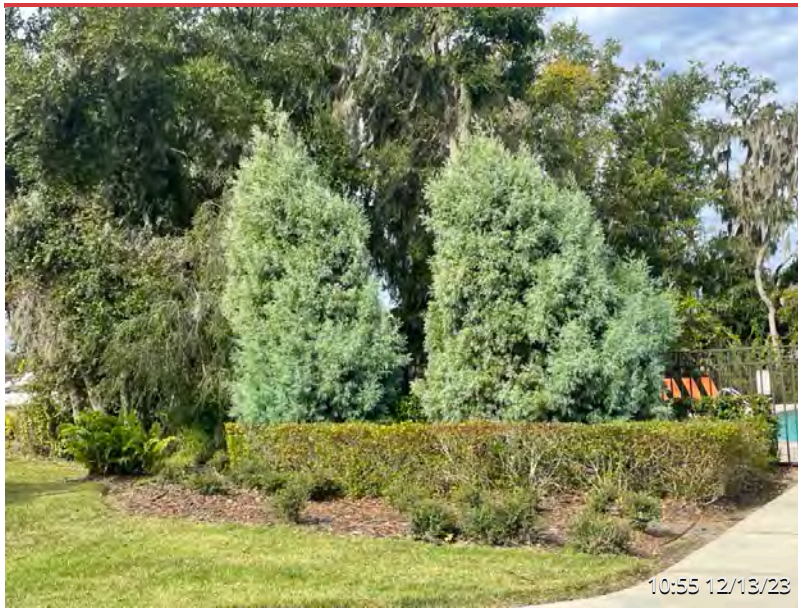
AMENITY CENTER.

Trim the ornamental grass off of the curbing.

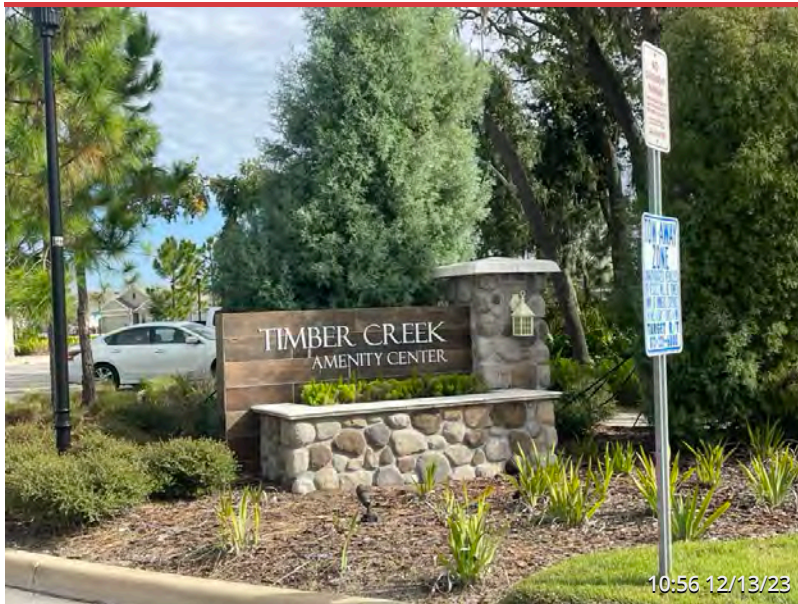
OPALINE SKY.

Send an estimate to straighten the Juniper trees.

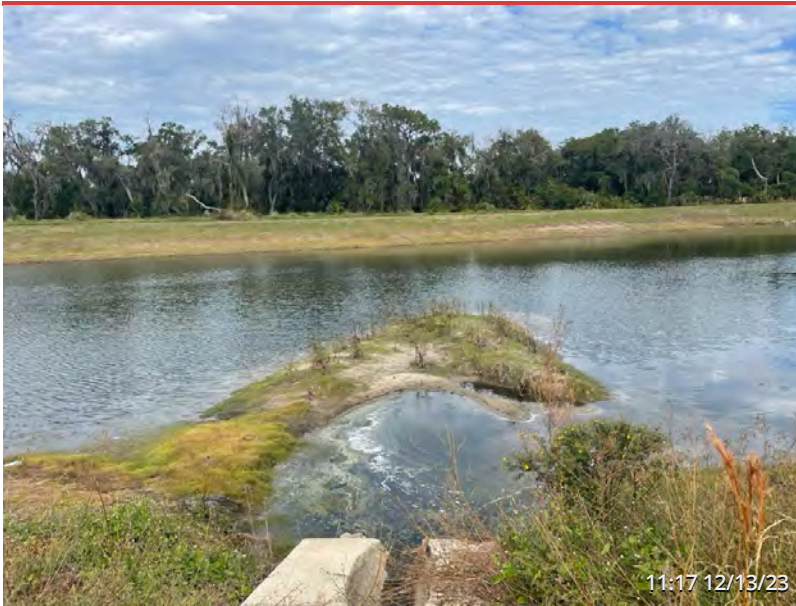
**NORTH POND.**

There is a filamentous algae bloom within the pond, and the pond is heavily receded.

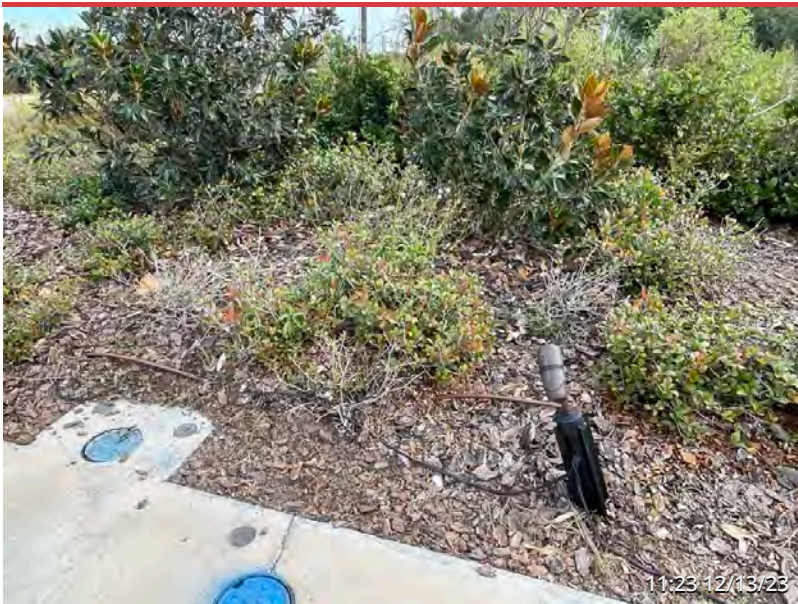
**MIRACLE MILE.**

Trim back the overgrown preserve area that is encroaching on the hedge plants.

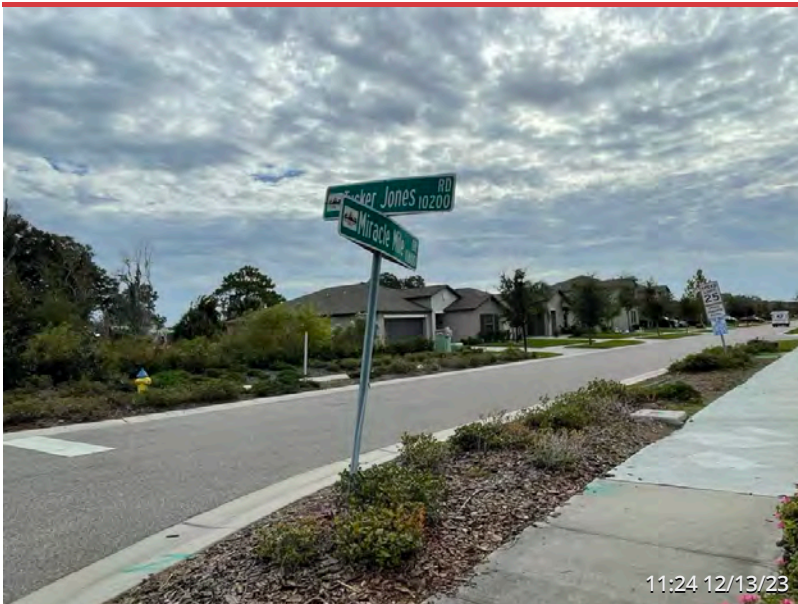
Remove the weeds and the plants.

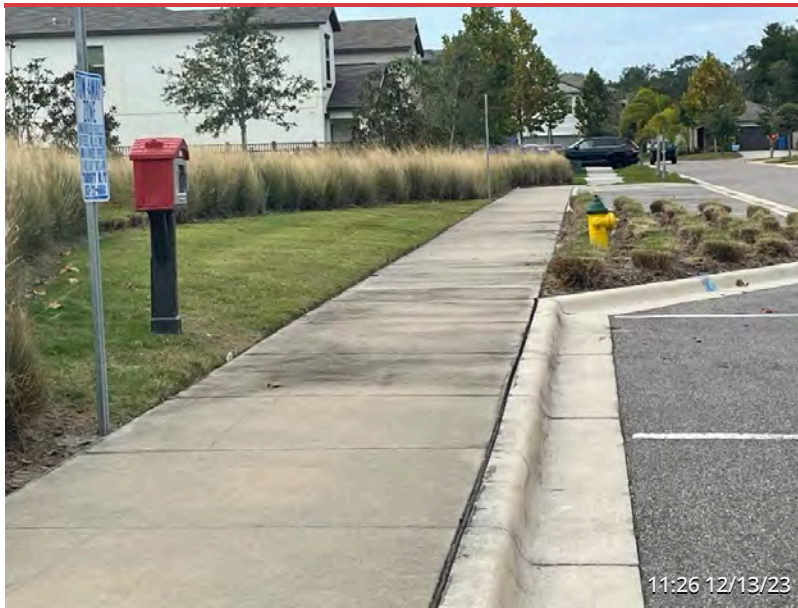
MIRACLE MILE.

The street sign on the NW corner is leaning.

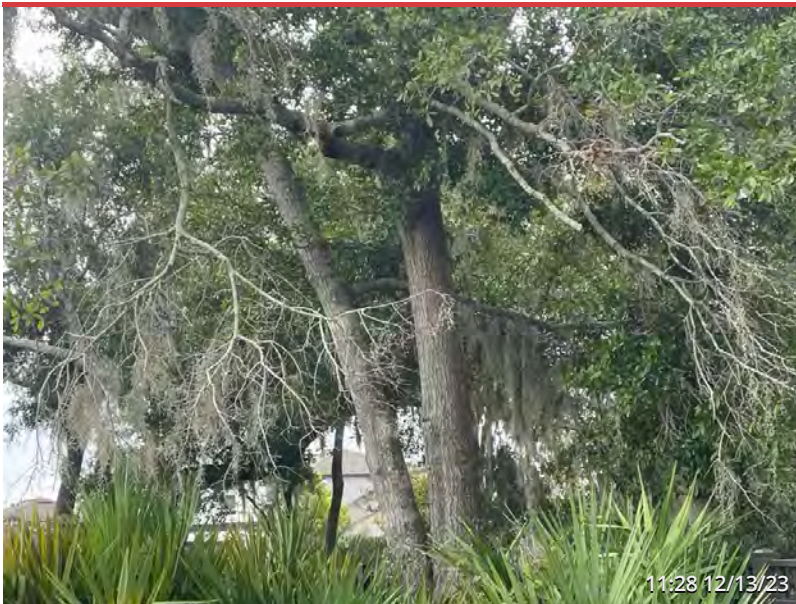
Remove the invasive plants
growing through the Fern plants

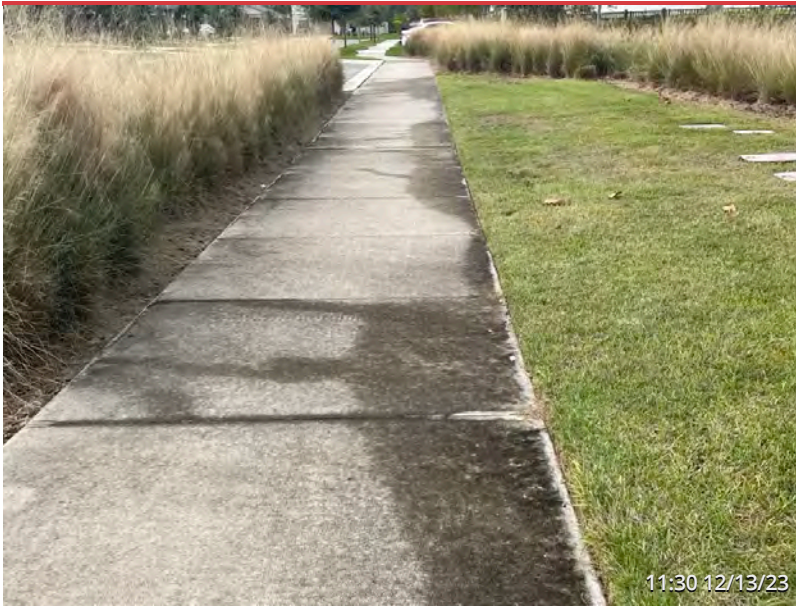
SUMMER KISS.

The turf fertility needs improvement.

The Zoysia turf is dormant this time of year and it causes the turf fertility to decline. The turf fertility will greatly improve with the warmer weather conditions.

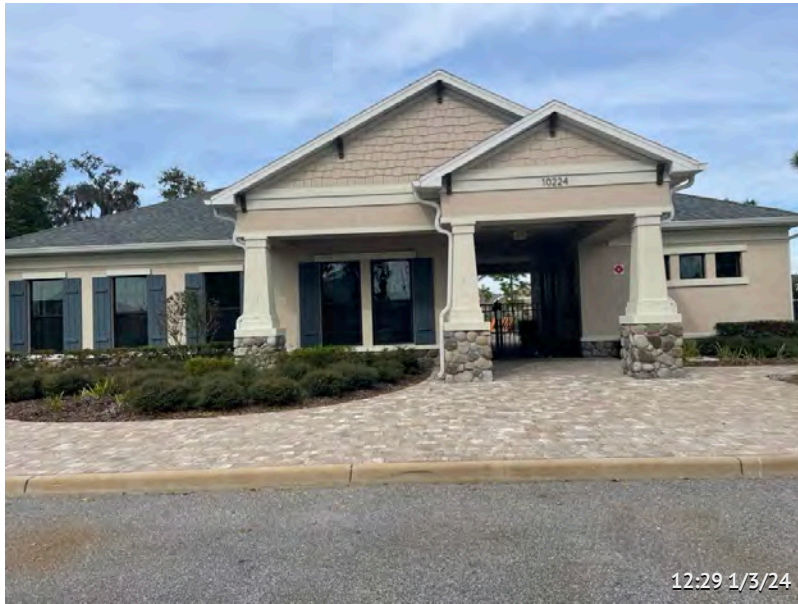
Amenity Center.

The Amenity center is clean and looks good. All bathrooms are clean and fully functional.

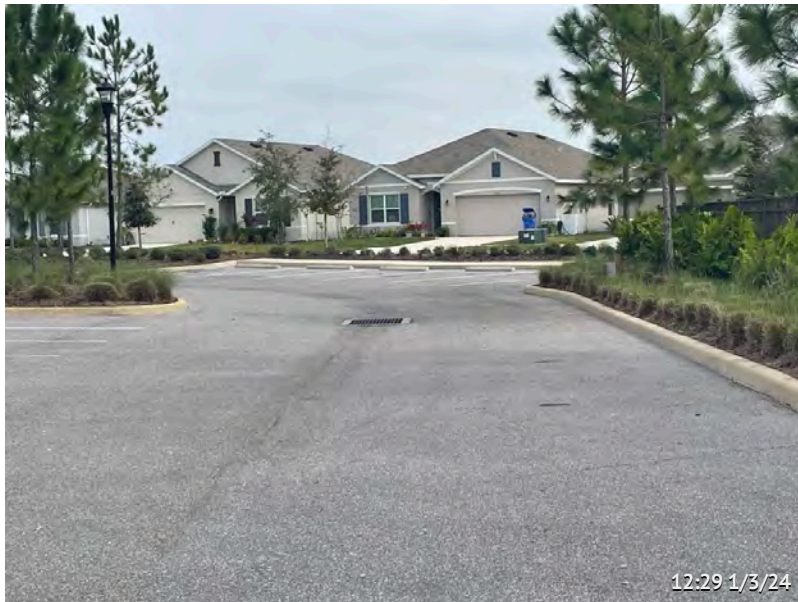
Amenity Center.

The parking lot is clean and looks good.

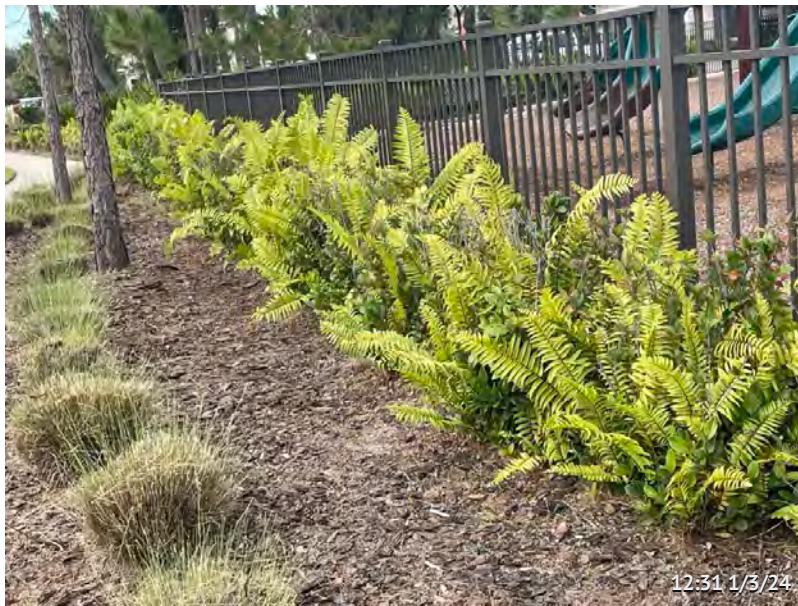
Opaline Sky

There are many Fern plants are growing through the Viburnum which need to be removed. Once removed, please instruct your crew to stay on top of this area, so this does not occur again.

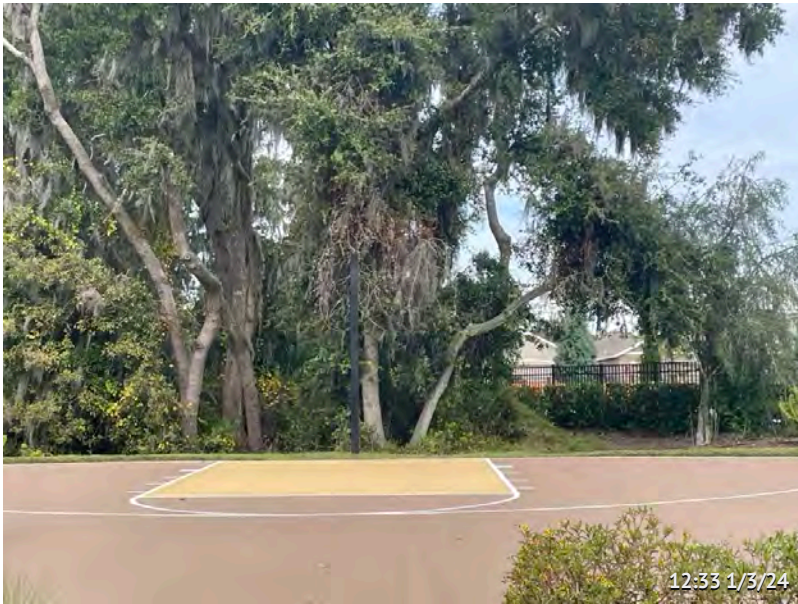
Amenity Center.

The basketball backboard is on order.

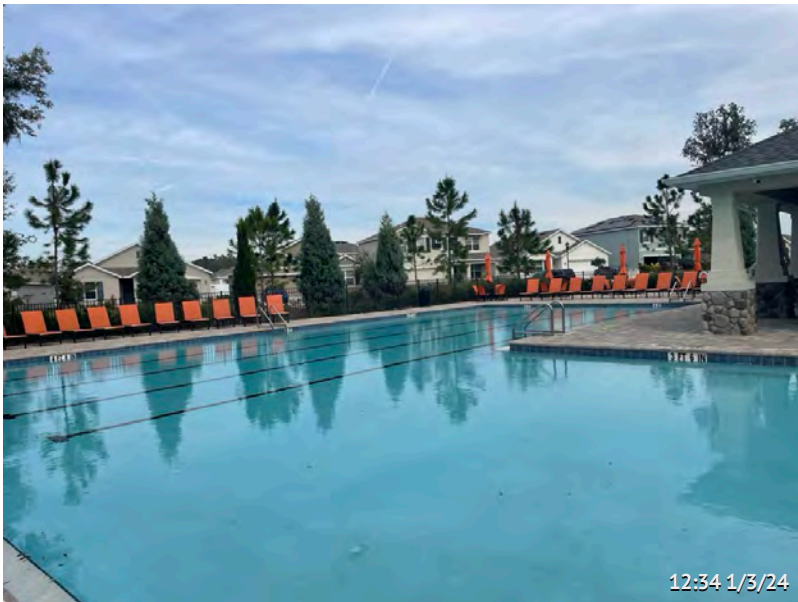
Amenity Center.

The pool is clear and blue. There are leaves in the pool that will be removed by the pool vendor.

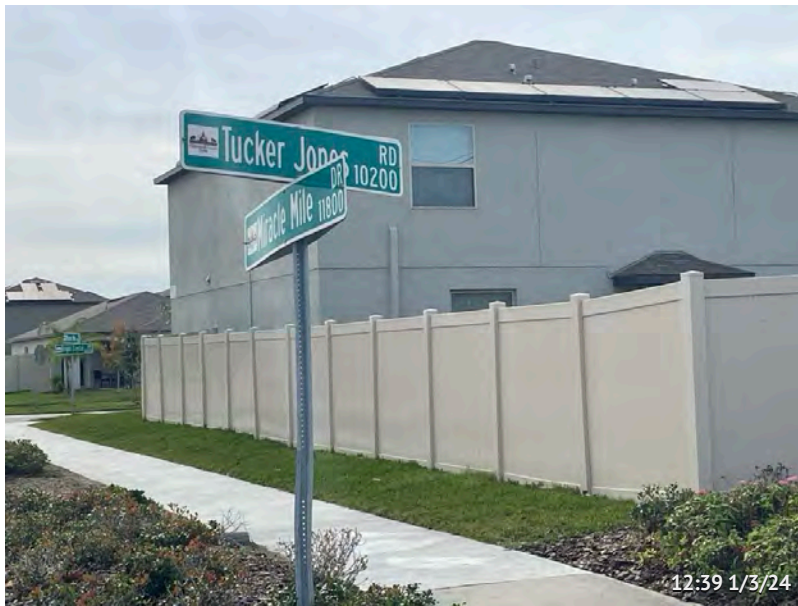
Miracle Mile.

The street sign needs to be straightened.

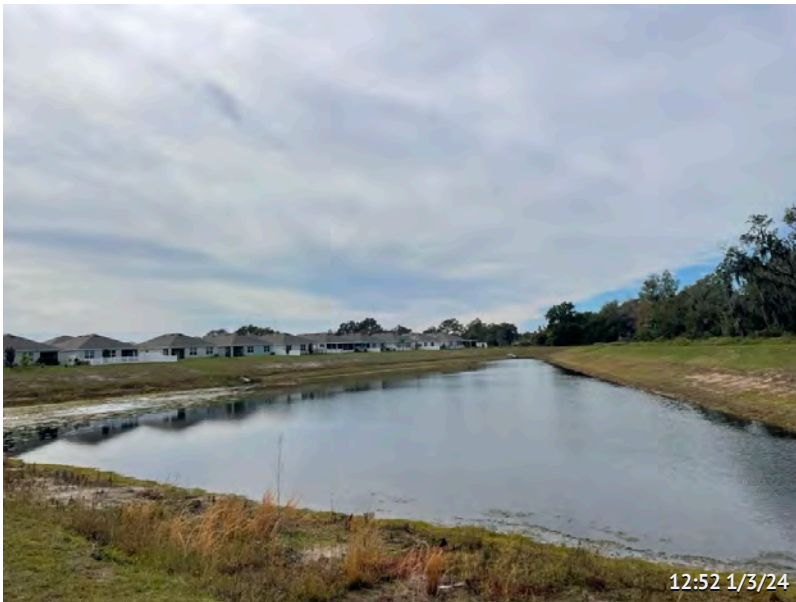
North Pond.

The SE end of the receded pond is very low.
